TECHNICAL REPORT 4842

**DYNAMIC ANALYSIS OF THE SAFING AND ARMING
SYSTEM FOR PD FUZE M572E2**

EDWIN B. ENTIN

**PICATINNY ARSENAL
DOVER, NEW JERSEY**

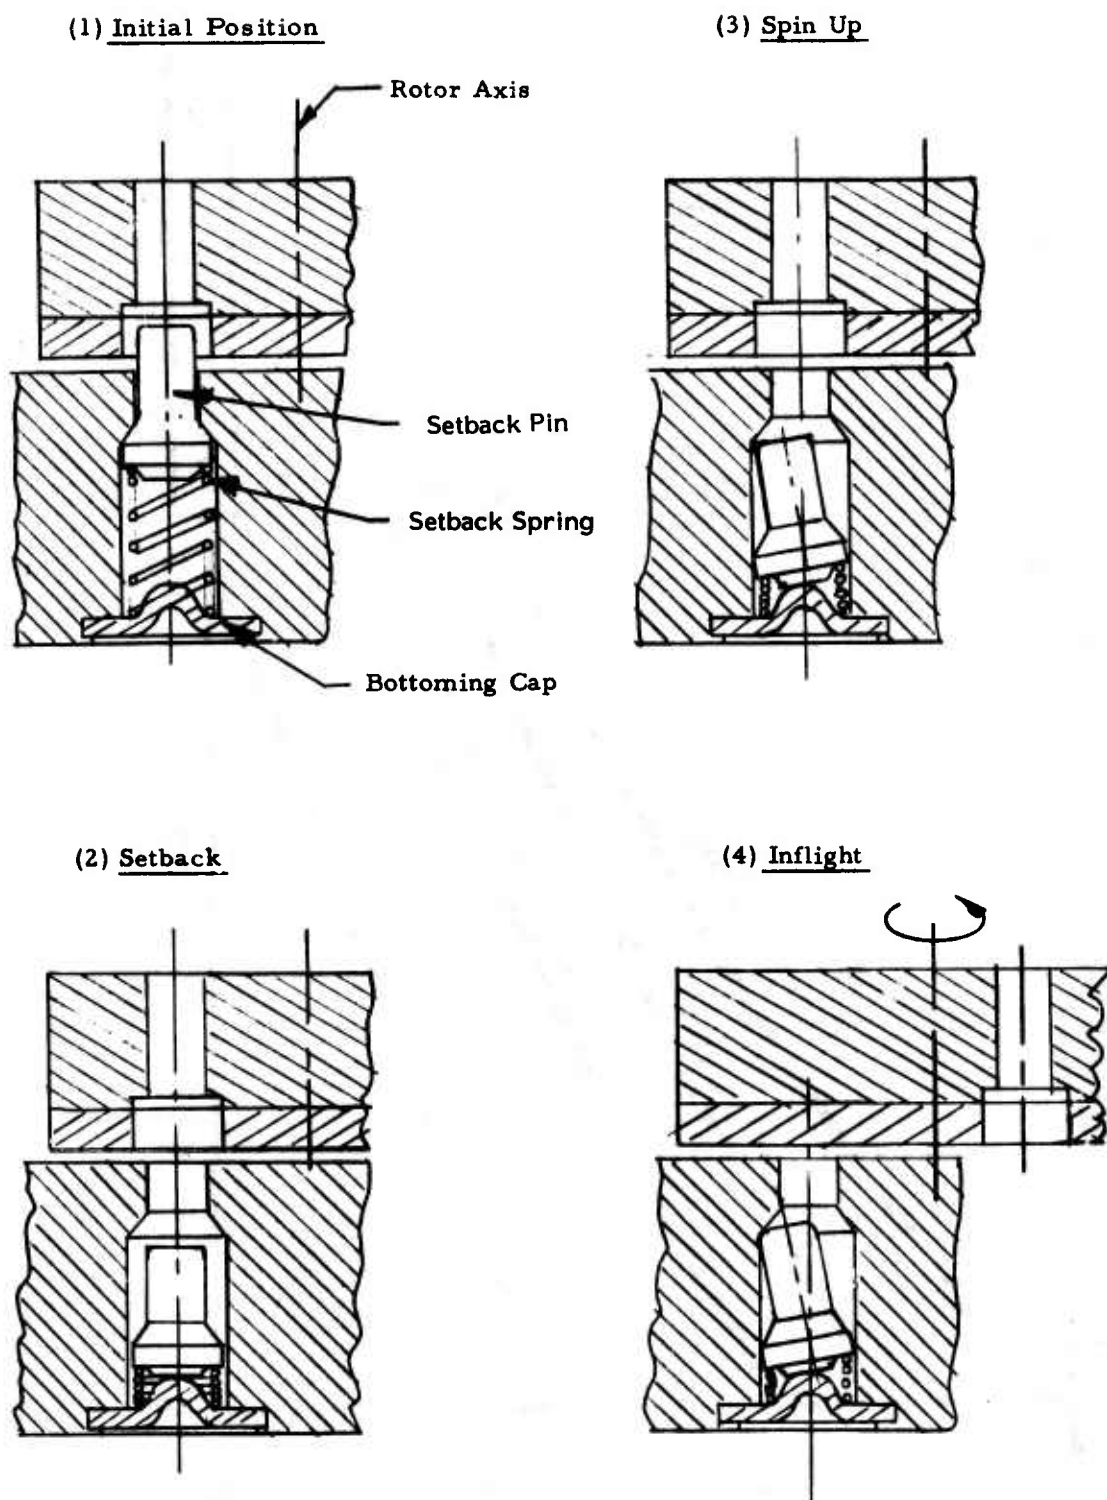
Fig 6 Setback-pin functioning sequence

the onset of setback, the pin moves aft and releases the rotor. With side forces arising from balloting or tube vibrations neglected for the moment, the pin, after several initial axial bounces, is expected to remain aft throughout most of the setback curve. As spin increases (Fig 6), the pin may pivot on the rather pointed top of the aluminum dimpled disc toward the cavity sidewall. When the muzzle is cleared, the spring force is insufficient to slide the pin forward against the retarding forces introduced by the side and ramp of the cavity, if the spin is high enough. Under most firing conditions, the setback pin apparently behaves as expected and the rotor is permanently released. The duds, though, were limited to low-zone firings of the 155 mm and 8-inch howitzers.

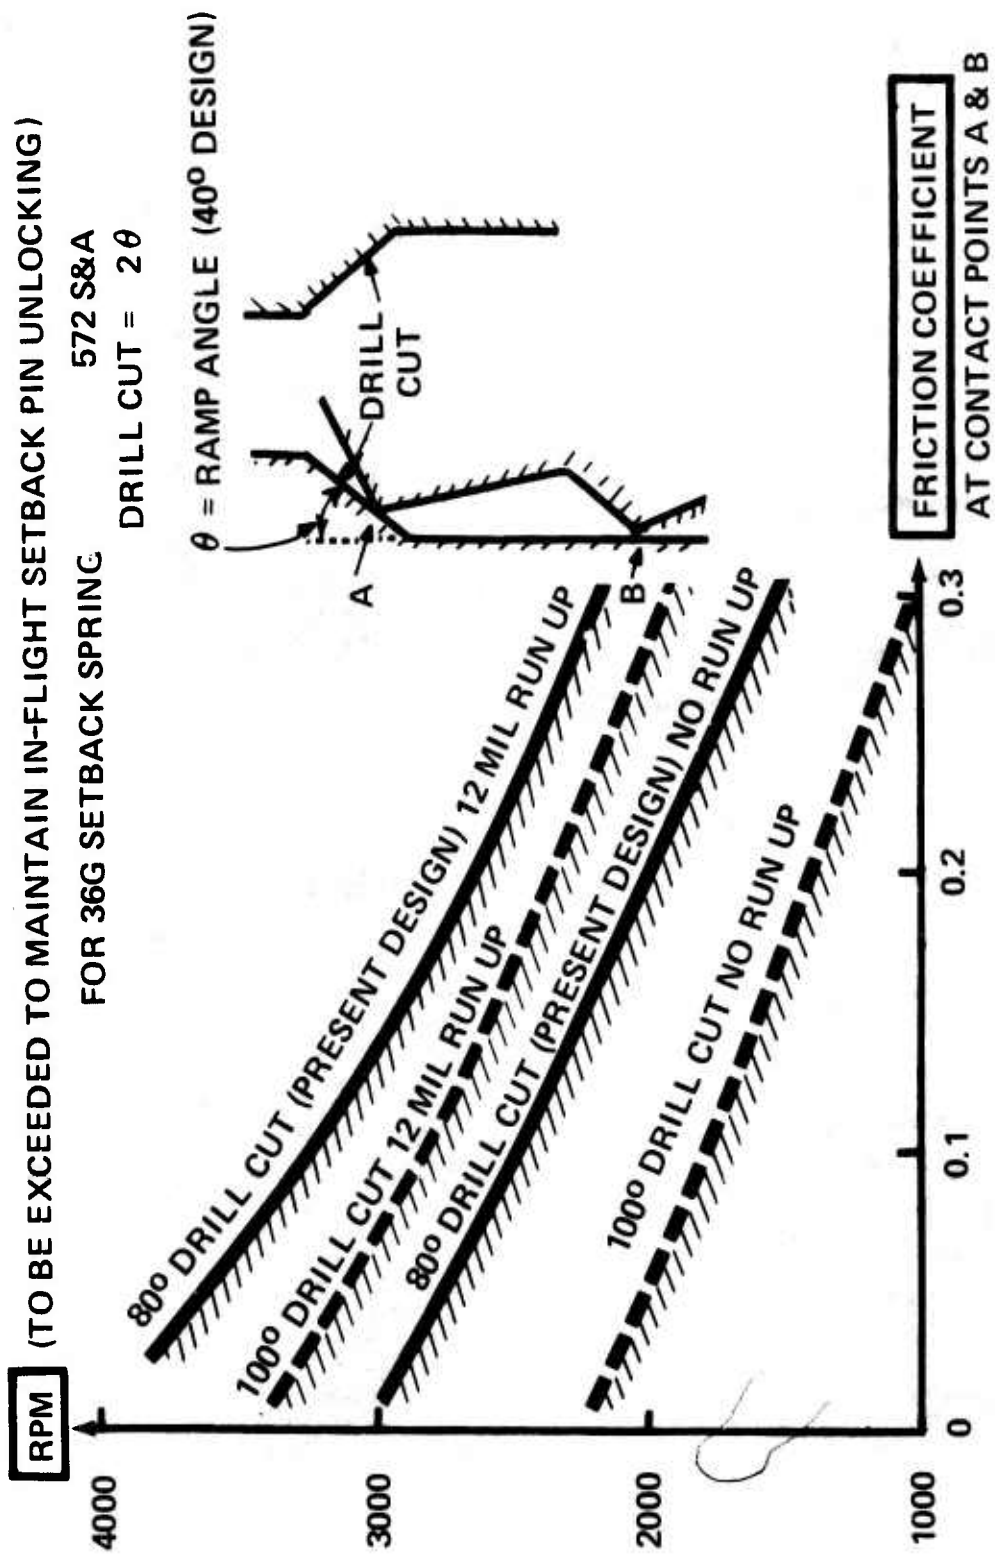
Fig 7 Setback-pin analysis

The dynamic analysis showed that for low-zone firings after the shell exited the muzzle, a degree of marginality was being reached in the design considered if the friction coefficient between pin and cavity began reaching a low value of about 0.15. The model considered pin motion up along the cavity wall and ramp under the influence of spring and spin forces. With the initial conditions of the pin in the bottomed, tilted position upon muzzle exit, the pin ordinarily did not reinsert; if it did, it occurred in about seven milliseconds after muzzle exit. Figure 7 shows this demarcation. Axial tolerances can allow the pin some "run up" distance along the wall before the ramp is engaged. Any introduction of appreciable side forces just at muzzle exit can produce temporary separation of the pin from the sidewall, resulting in an "effective" lowered friction coefficient.

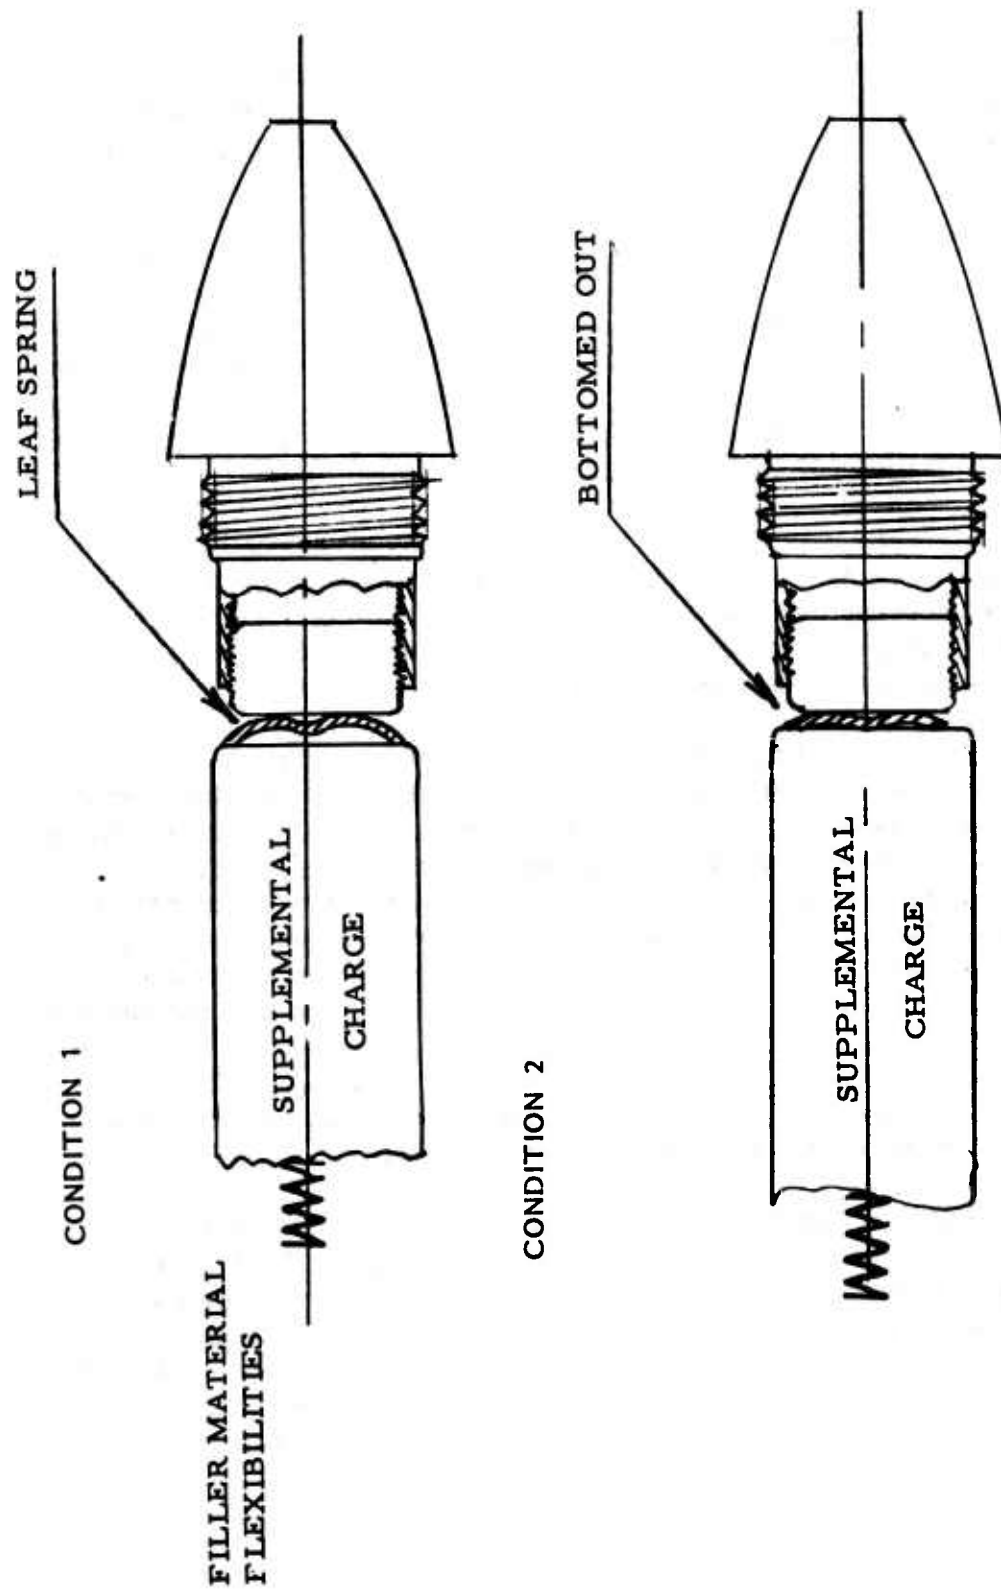
Fig 12 Supplemental charge model

The model includes elastic collisions of the pin in bottoming out and reseating impacts. Another subsystem included in the model is the supplemental charge in its relative motion within its cavity toward the fuze. The retaining leaf spring operates in two stiffness zones due to the bottoming out of the center section. This sudden change in stiffness can result in an impulse being applied directly to the boosting charge cap which, in turn, could excite unwanted setback-pin response (see Fig 12).

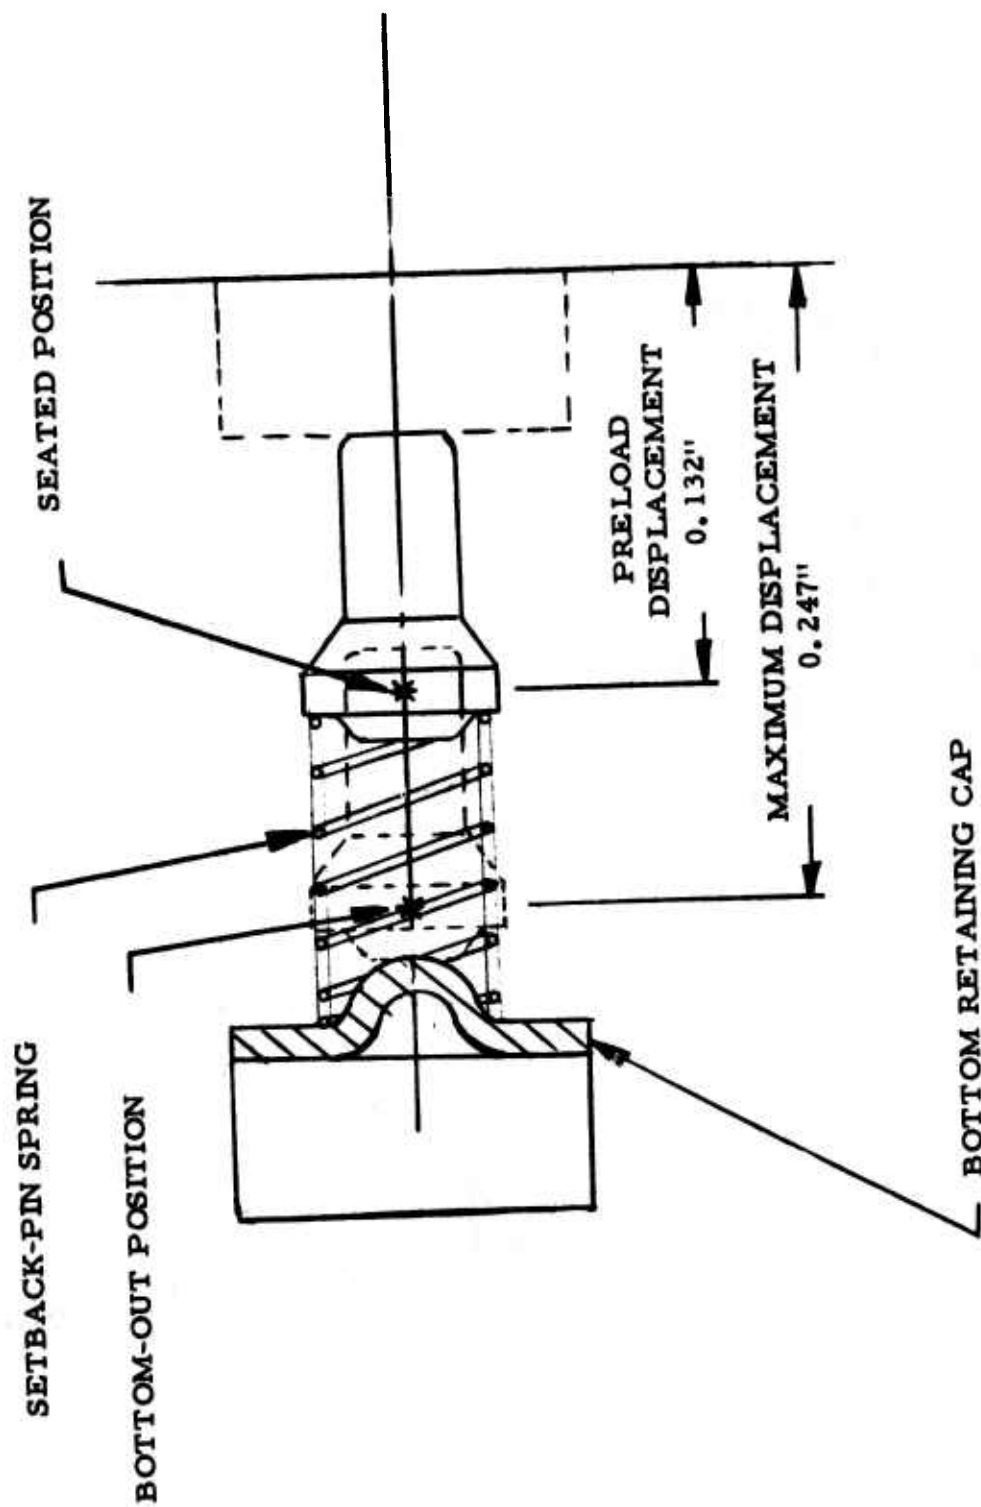
Fig 13 Setback-pin model

In view of the fact that the structural flexibility appeared negligible for the zone 1 simulation, this model was downgraded to a much simpler model consisting of only three degrees-of-freedom (Fig 13). This model was exercised for the same conditions in order to compare setback-pin responses. The response was essentially identical to the response generated by the 33 degrees-of-freedom system. Consequently, the simpler model was used to investigate pin response as a function of simulated engineering design changes.

Five runs were made with increased damping for the setback-spring motion between boundaries, while keeping boundary collisions with zero damping (perfectly elastic). This was recognized to be a very conservative assumption. The rationale involved searching for a positive fix to the problem which would effect a solution under the worst conditions. (These conditions included perfectly elastic rebounding and continuous lateral alignment.) Relative damping ratios of 25-, 50-, 100-, 1,000-, and 10,000- percent critical were investigated. The time for initial re-seating ranged from almost immediately after muzzle exit for 25 percent critical, to about five milliseconds for 100 percent, to about 54 milliseconds for 1,000 percent. One of the pertinent results demonstrated by these solutions is that if the pin comes to a position of alignment for any of the reasons discussed above, even without rebounding motion, the setback-pin spring itself can cause reseating shortly after muzzle exit. The 25-, 50-, 100-, and 1,000-percent critical conditions are illustrated in Figures 14, 15, 16, and 17, respectively, where muzzle exit occurs at 29.5 millisecond (0.0295 time). The ordinate "0.25" represents pin bottoming, and the ordinate "0.13" represents seating of the pin in the rotor. For pin motion unrestrained by friction forces along the cavity wall, it was apparent that significant dash-pot type damping is required to guarantee successful operation after the shell leaves the muzzle.

1. Added damping to the motion of the setback pin while the pin is moving between its axial boundaries.
2. Changing the stiffness of the setback-pin spring.
3. Increasing the setback-pin stroke.

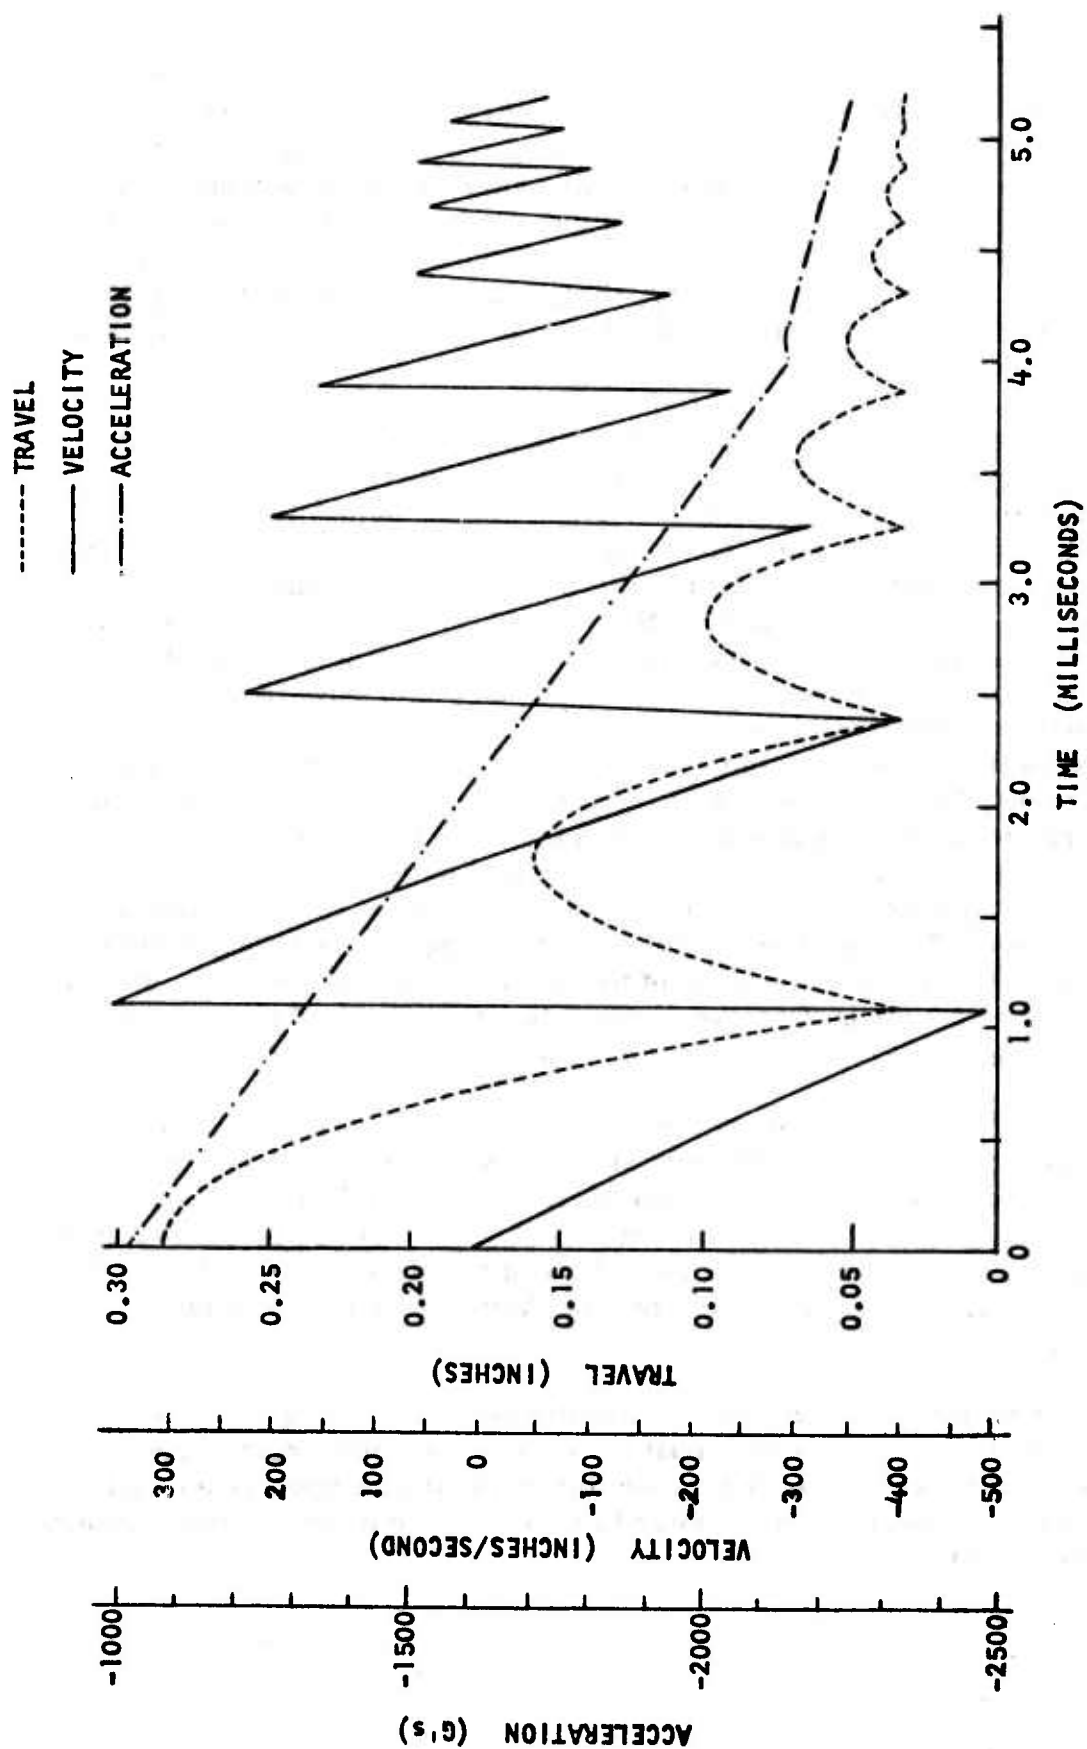
Fig 20 Parabolic-type bounce for tungsten setback-pin design (PA-34)

surface, centrifugal acceleration is insufficient to cause the pin to tilt toward the wall while the projectile is still in the barrel. Thus, for such a configuration, the pin will remain bottomed, but upright. On exit, the setback acceleration disappears, and centrifugal force will act to tip the pin. The model showed that six of the eight pins will tip over in about two milliseconds. The slide program, discussed below, indicated that in most cases, for a long cavity, the pin will not have reached the ramp position by that time; therefore, the tip of the pin will be trapped behind the ramp.
